# Main Building of Vilnius Gediminas Technical University (VGTU)

The challenge in this project was to show how energy efficient solutions can be achieved in applying the methodology of multi-variant design and multiple criteria analysis of a building refurbishment by forming thousands of alternative versions. This methodology allowed to determine the strongest and weakest points of each the Main Building's VGTU refurbishment project and its constituent parts.

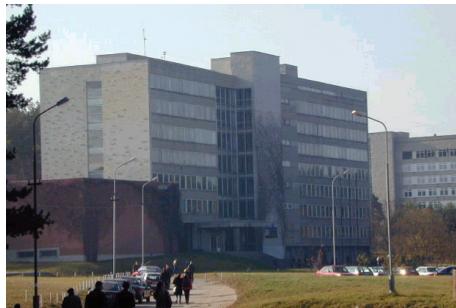
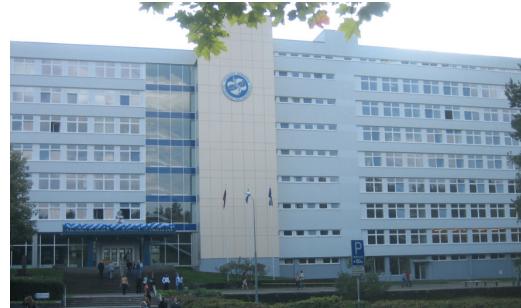
Main Building of VGTU before and after retrofit

The conclusions of an energy audit (performed in 2002) showed that 14–16 °C was the average temperature in premises during a heating season. The indoor air temperature increased by 2–4 degrees after replacement of windows, insulation of roof and renovation of the thermal unit. Now the indoor air temperature meets the specifications of HN 42:2004 requirements.

It was possible to compare the data on energy consumption before the renovation and during the renovation. In summer of 2004, the windows of the Main Building were replaced. In autumn of 2005, the roof and walls of the semi-basement were insulated. In 2003, the energy consumption was 920,000 kWh, and in 2005 already 532,000 kWh, i.e. it decreased by 42 %. In 2006, the energy consumption made up 547,000 kWh. Compared to 2003, the energy consumption decreased by 41 %. Comparisons were made irrespective of winter conditions. It is a rough estimation of renovation effectiveness. In 2005, electricity consumption decreased by about 16 % compared to 2003, and compared to 2004 by 26 %.
